**Flood Control Project Maintenance
Levee Inspections**

Spring 2012 Levee Inspection Results

Sacramento Maintenance Yard Maintenance Area 0009

Waterway			Bank	Unit Miles
Unit No. 01 Sacramento River			Left	19.61
	Spring (March - May)	Summer (June - August)	(September - November) Fall	Winter (December - February)
Unit Maintenance Rating (Fall Only)				
Date of Inspection	5/1/2012 - 5/2/2012			
DWR Inspector	John Williamson			
Accompanied By	Dave Williams Sacramento Maint.			
	Iris Flores Sacramento Maint.

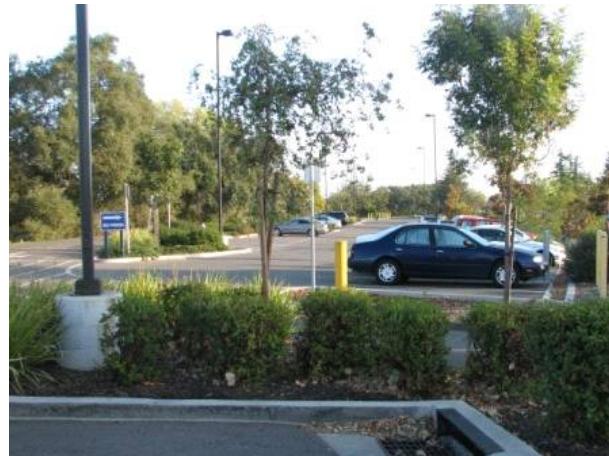
Levee Mile Report Line	5
Start Levee Mile	0.40
End Levee Mile	0.48
Location	Crown
Category	Earthen Levee
Item	Vegetation
A view of the parking area and landscape. Fall 2011	
<i>johngw_s_20120313_029.jpg</i>

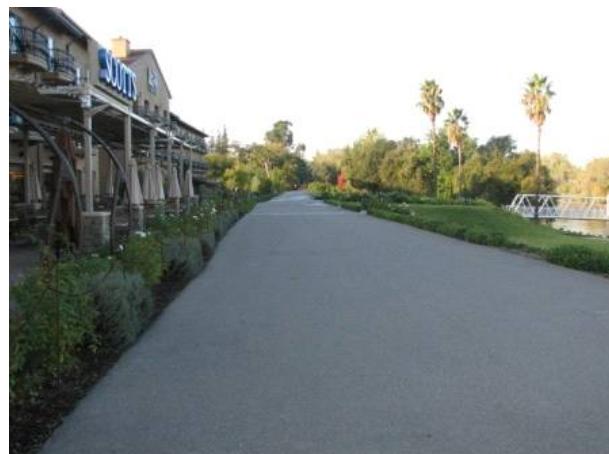
Levee Mile Report Line	6
Start Levee Mile	0.48
End Levee Mile	0.65
Location	Water Side
Category	Earthen Levee
Item	Vegetation
The landscape that is planted on the crown of the levee. Fall 2011	
<i>johngw_s_20120313_031.jpg</i>

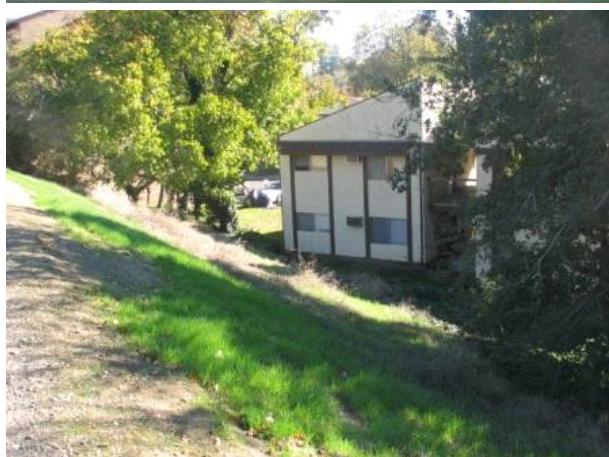
The apartments are within the easement of the levee toe.

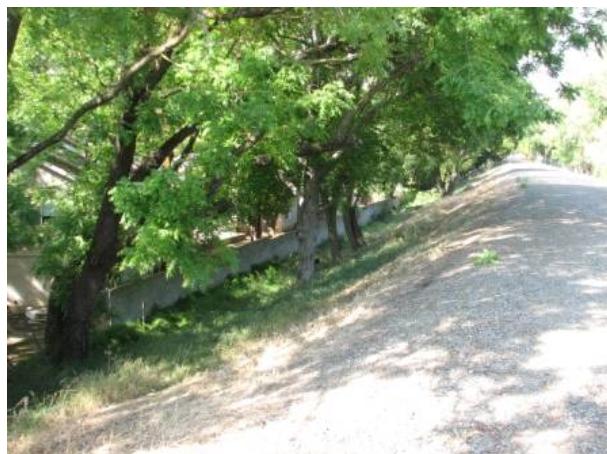
Levee Mile Report Line	12
Start Levee Mile	0.72
End Levee Mile	0.78
Location	Land Side
Category	Earthen Levee
Item	Encroachments
The block wall fence is located at the toe of the levee.	
johngw_s_20120313_033.jpg

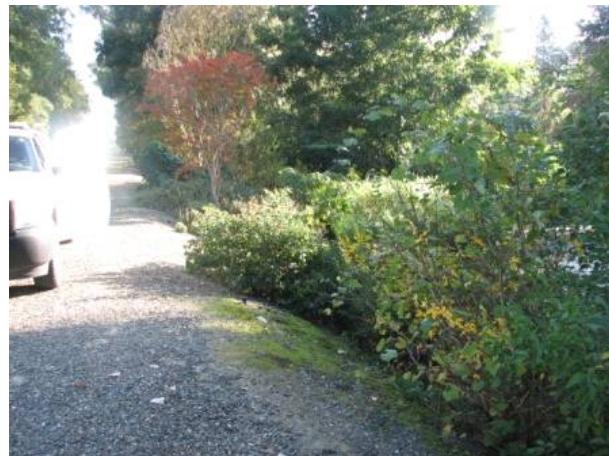
Levee Mile Report Line	18
Start Levee Mile	0.93
End Levee Mile	0.94
Location	Land Side
Category	Earthen Levee
Item	Vegetation
Landscape shrubs and trees are blocking visibility of the levee slope. Fall 2011	johngw_s_20120313_036.jpg

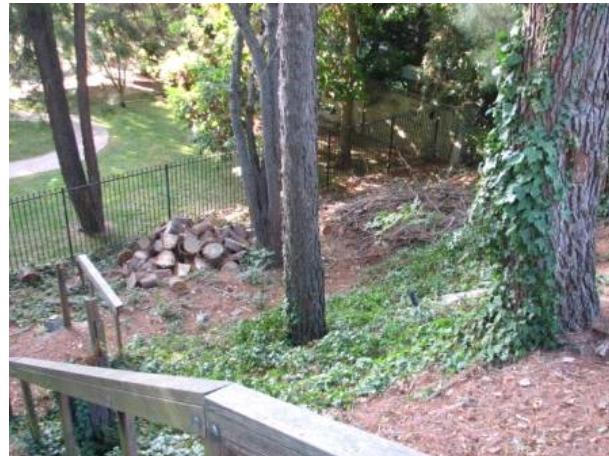
Levee Mile Report Line	22
Start Levee Mile	1.00
End Levee Mile	1.02
Location	Land Side
Category	Earthen Levee
Item	Vegetation
Ivy groundcover covers part of the levee slope and wood debris from trimmings is left at the toe. Fall 2011	johngw_s_20120313_041.jpg

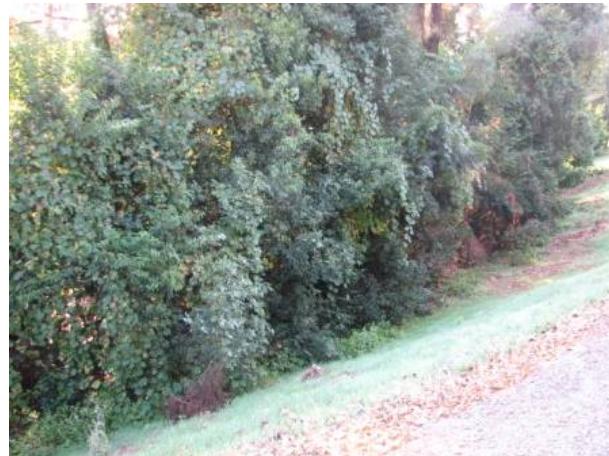
Levee Mile Report Line	28
Start Levee Mile	1.27
End Levee Mile	1.31
Location	Land Side
Category	Earthen Levee
Item	Vegetation
The trees and vegetation makes it hard to see through to the toe. Fall 2011	
johngw_s_20120313_050.jpg

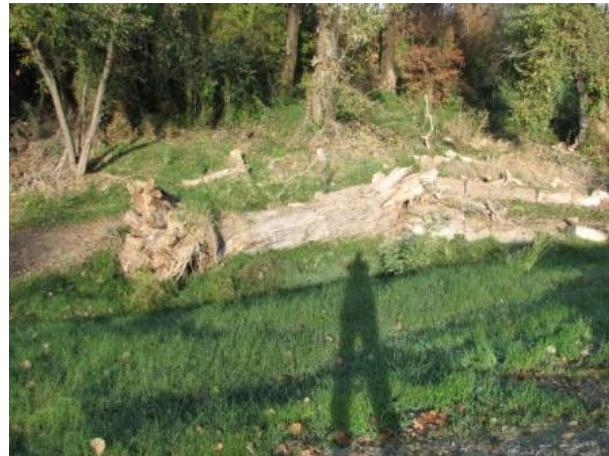
Levee Mile Report Line	29
Start Levee Mile	1.29
End Levee Mile	1.29
Location	Water Side
Category	Earthen Levee
Item	Encroachments
A large cottonwood tree at toe of levee fell. Fall 2011	
johngw_s_20120313_042.jpg

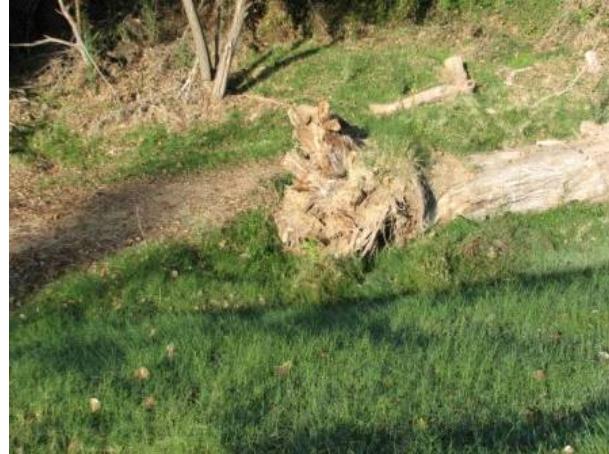
Levee Mile Report Line	29
Start Levee Mile	1.29
End Levee Mile	1.29
Location	Water Side
Category	Earthen Levee
Item	Encroachments
The rootball took a small divot out of the toe of the levee. Fall 2011	
johngw_s_20120313_043.jpg

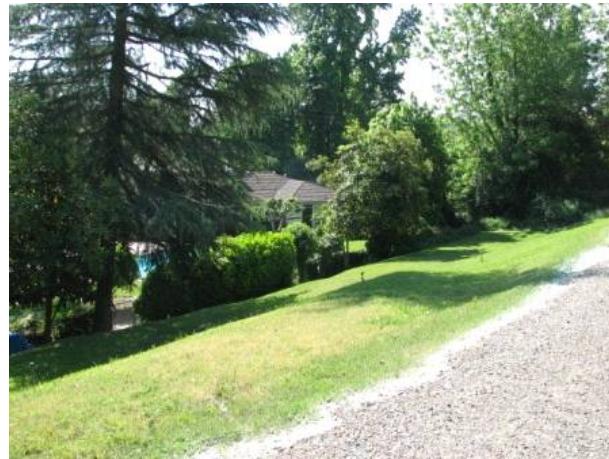
Levee Mile Report Line	30
Start Levee Mile	1.31
End Levee Mile	1.34
Location	Land Side
Category	Earthen Levee
Item	Vegetation
Hedges block the view of the toe and backyard.	
johngw_s_20120313_051.jpg

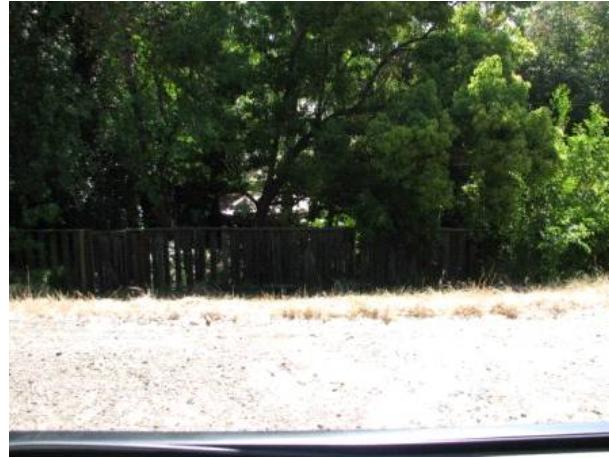
Levee Mile Report Line	32
Start Levee Mile	1.34
End Levee Mile	1.36
Location	Land Side
Category	Earthen Levee
Item	Encroachments
The wooden fence along the toe is hard to see through.	
johngw_s_20120313_053.jpg

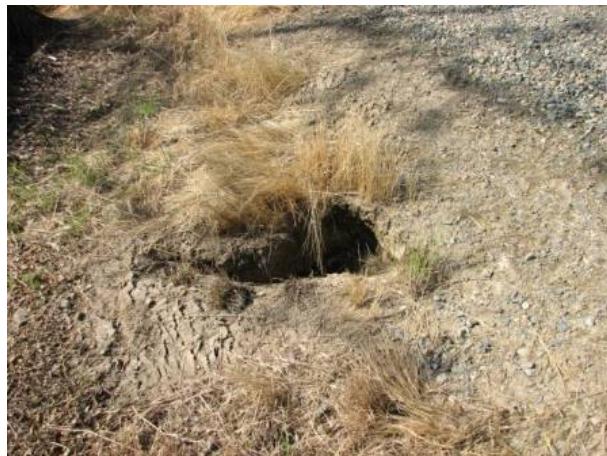
Levee Mile Report Line	34
Start Levee Mile	1.37
End Levee Mile	1.37
Location	Land Side
Category	Earthen Levee
Item	Animal Control
A rodent hole on the shoulder is very large. Photo taken spring 2012.	
johngw_s_20120504_755.jpg

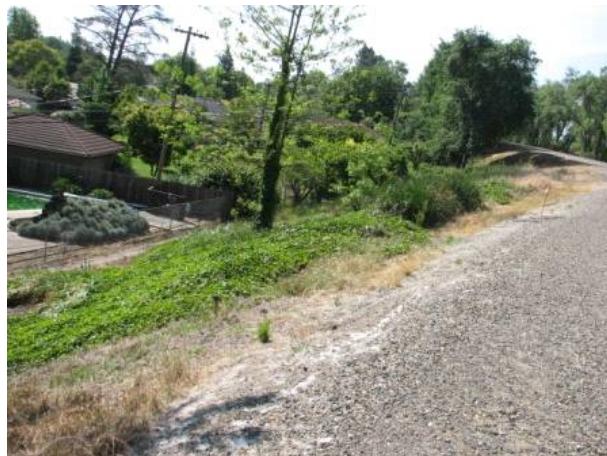
Levee Mile Report Line	35
Start Levee Mile	1.38
End Levee Mile	1.40
Location	Land Side
Category	Earthen Levee
Item	Vegetation
Ivy completely covers the ground.	
johngw_s_20120313_054.jpg

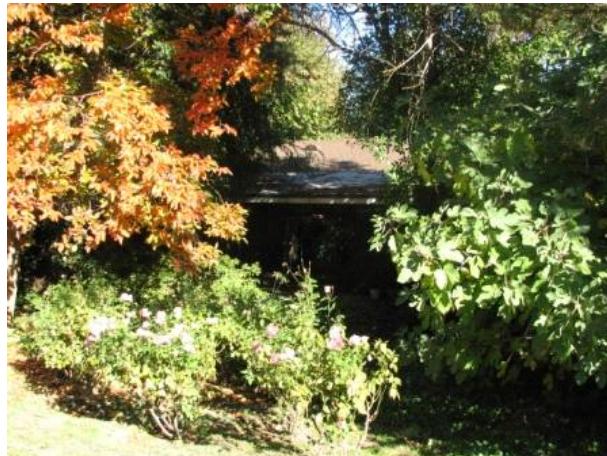
Levee Mile Report Line	40
Start Levee Mile	1.91
End Levee Mile	1.91
Location	Land Side
Category	Earthen Levee
Item	Encroachments
The house is on the crown with landscaping up to the shoulder.	
<i>johngw_s_20120313_057.jpg</i>

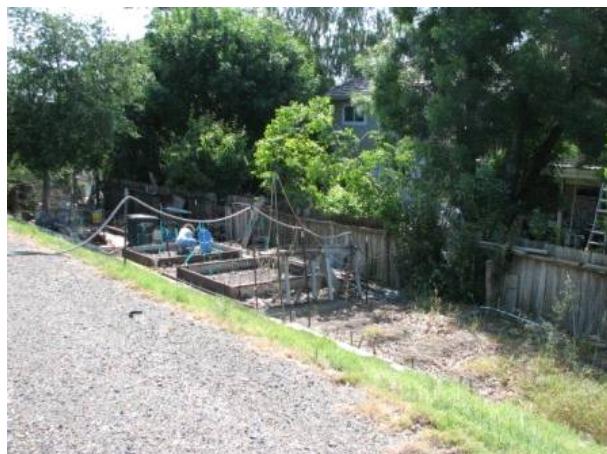
Levee Mile Report Line	45
Start Levee Mile	2.85
End Levee Mile	2.86
Location	Land Side
Category	Earthen Levee
Item	Vegetation
The garden area is at the toe of the levee.	
johngw_s_20120313_060.jpg

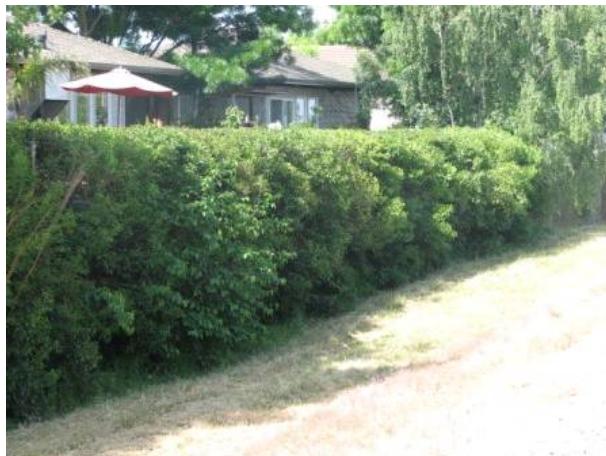
Levee Mile Report Line	75
Start Levee Mile	3.62
End Levee Mile	3.65
Location	Land Side
Category	Earthen Levee
Item	Vegetation
The hedge blocks the view of the levee berm. Photo taken spring 2012.	
<i>johngw_s_20120504_761.jpg</i>

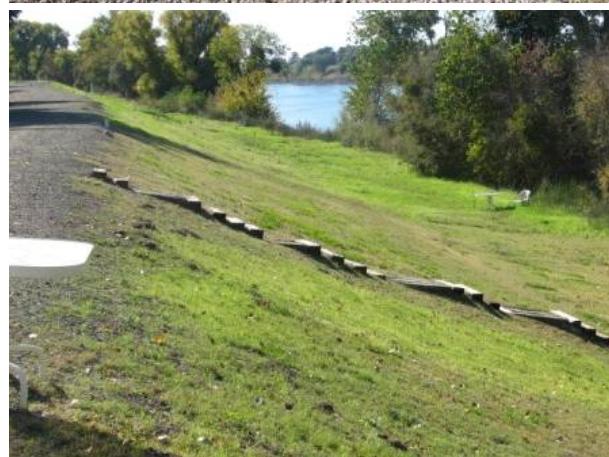
Levee Mile Report Line	96
Start Levee Mile	3.98
End Levee Mile	3.99
Location	Land Side
Category	Earthen Levee
Item	Vegetation
Stairs are on the waterside levee slope.	
<i>johngw_s_20120313_072.jpg</i>

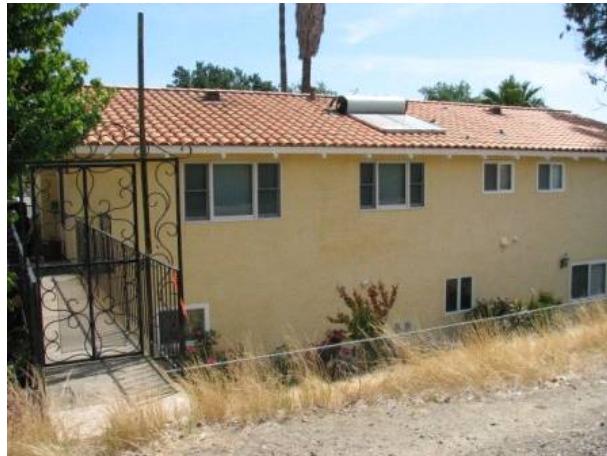
Levee Mile Report Line	133
Start Levee Mile	5.02
End Levee Mile	5.02
Location	Land Side
Category	Earthen Levee
Item	Encroachments
The two story house was built at the toe of the levee.	
johngw_s_20120313_080.jpg

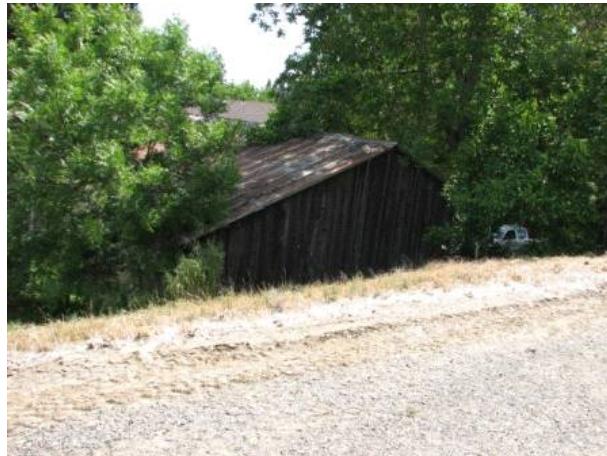
Levee Mile Report Line	136
Start Levee Mile	5.05
End Levee Mile	5.05
Location	Land Side
Category	Earthen Levee
Item	Encroachments
The side of the barn is into levee toe.	
<i>johngw_s_20120313_082.jpg</i>

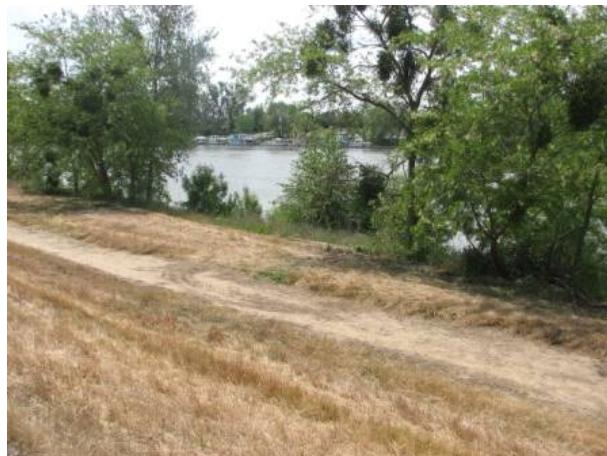
Levee Mile Report Line	147
Start Levee Mile	5.55
End Levee Mile	5.81
Location	Water Side
Category	Earthen Levee
Item	Vegetation
A revegetation site along the berm. Photo taken spring 2012.	
johngw_s_20120504_770.jpg

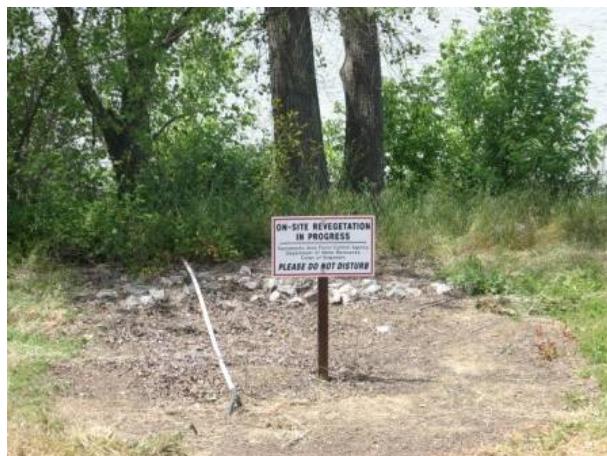
Levee Mile Report Line	147
Start Levee Mile	5.55
End Levee Mile	5.81
Location	Water Side
Category	Earthen Levee
Item	Vegetation
The sign and irrigation pipe in revegetation site. Photo taken spring 2012.	
johngw_s_20120504_771.jpg

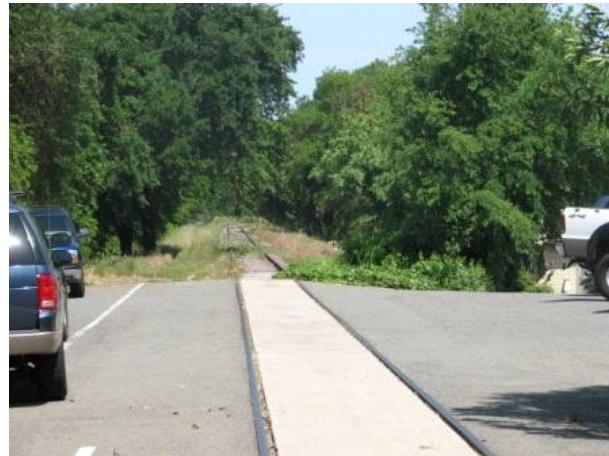
Levee Mile Report Line	164
Start Levee Mile	9.31
End Levee Mile	9.71
Location	Land Side
Category	Earthen Levee
Item	Encroachments
A view from the parking lot of the marina on the downstream side of Freeport.	
<i>johngw_s_20120504_783.jpg</i>

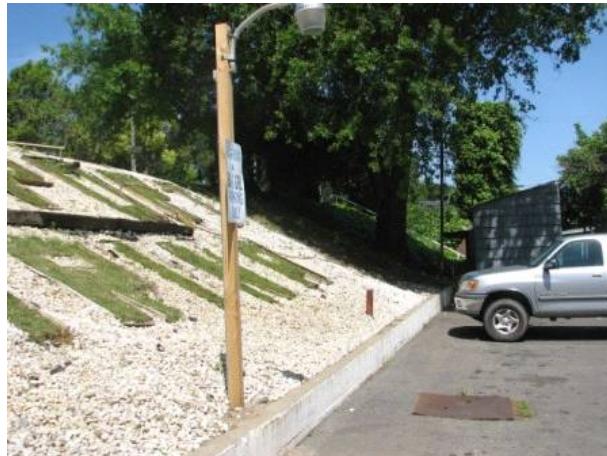
Levee Mile Report Line	183
Start Levee Mile	9.67
End Levee Mile	9.70
Location	Land Side
Category	Earthen Levee
Item	Vegetation
A view of the landscape on the levee slope. Photo taken spring 2012.	
johngw_s_20120504_778.jpg

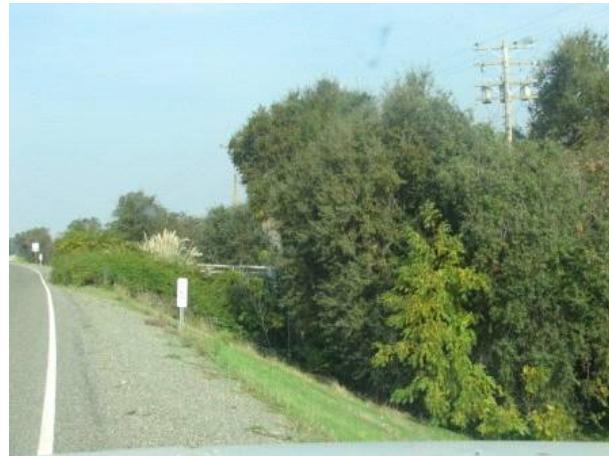
Levee Mile Report Line	205
Start Levee Mile	14.43
End Levee Mile	14.43
Location	Land Side
Category	Earthen Levee
Item	Vegetation
Trees and shrubs planted along the toe and on the slope lining the drive.	
johngw_s_20120313_102.jpg

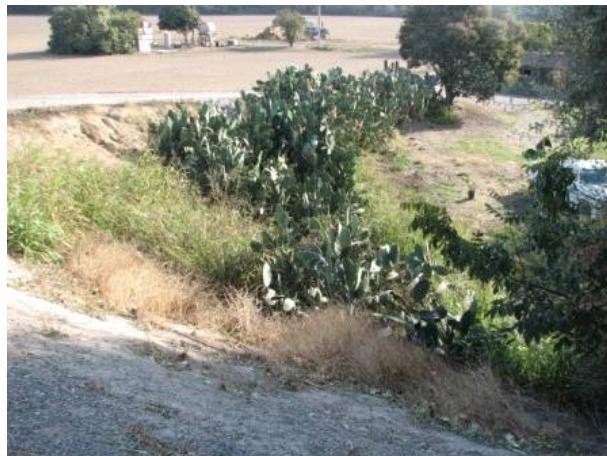
Levee Mile Report Line	209
Start Levee Mile	15.94
End Levee Mile	15.94
Location	Land Side
Category	Earthen Levee
Item	Vegetation
Some cactus is planted at the toe of the levee. Fall 2011	
<i>johngw_s_20120313_101.jpg</i>

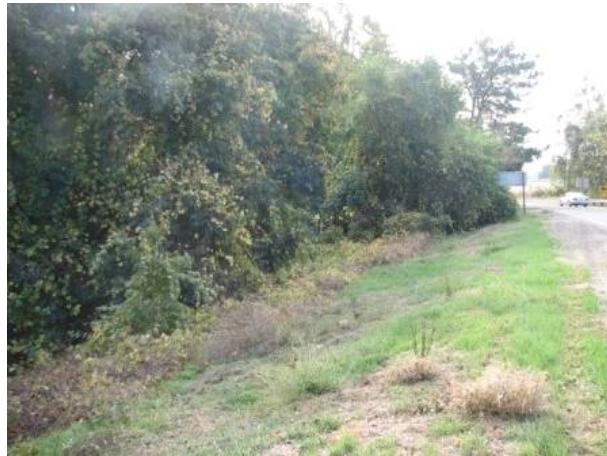
Levee Mile Report Line	217
Start Levee Mile	17.59
End Levee Mile	17.59
Location	Land Side
Category	Earthen Levee
Item	Vegetation
Trees and shrubs are planted to screen the house upstream of Hood. Fall 2011	
<i>johngw_s_20120313_098.jpg</i>

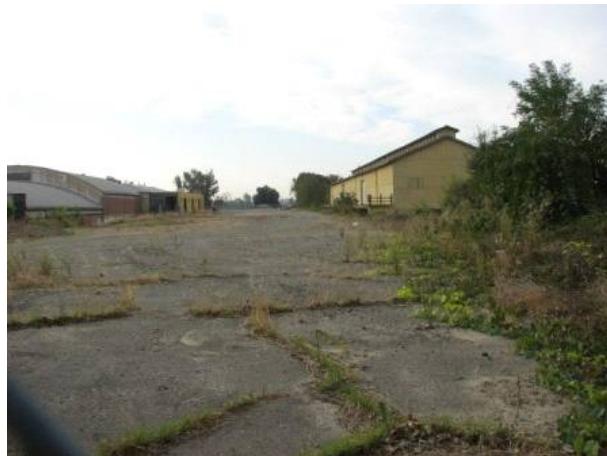
Levee Mile Report Line	219
Start Levee Mile	17.85
End Levee Mile	17.85
Location	Land Side
Category	Earthen Levee
Item	Encroachments
Old pumphouse downstream of Hood building cuts into the toe of the levee. Fall 2011	
johngw_s_20120313_097.jpg

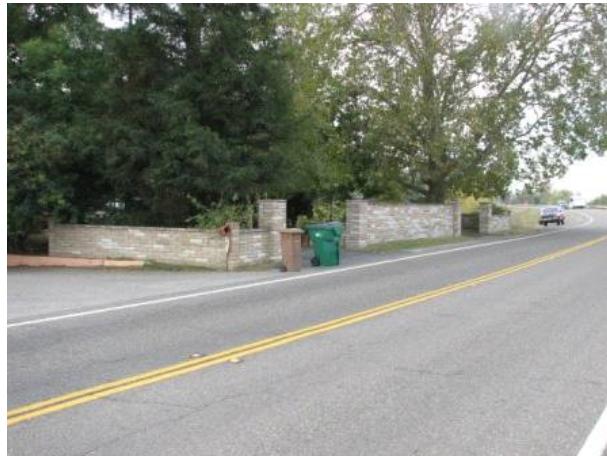
Levee Mile Report Line	222
Start Levee Mile	18.57
End Levee Mile	18.57
Location	Land Side
Category	Earthen Levee
Item	Encroachments
A brick wall separates the roadway and the rest of the landscape on the levee. Fall 2011	
johngw_s_20120313_115.jpg

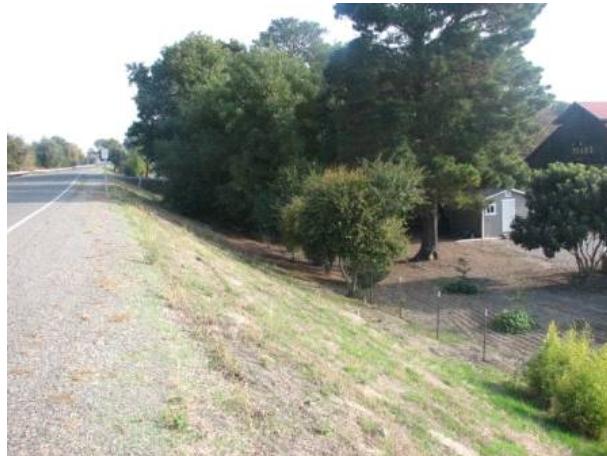
Levee Mile Report Line	225
Start Levee Mile	19.06
End Levee Mile	19.06
Location	Land Side
Category	Earthen Levee
Item	Vegetation
Wire fencing, trees and shrubs are planted along the toe of the levee.	
johngw_s_20120313_095.jpg
